1. PURPOSE AND SCOPE OF THIS MEMORANDUM

This memorandum summarizes a site survey performed on July 18, 2008 to evaluate the condition of ADA-mandated accessibility at the Recreation Center in Pembroke Massachusetts. After a description of the site and interior conditions of the building, recommended improvements are provided in Section 7, beginning on page 9.

The subject property is the Pembroke Recreation Center at 128 Center Street.

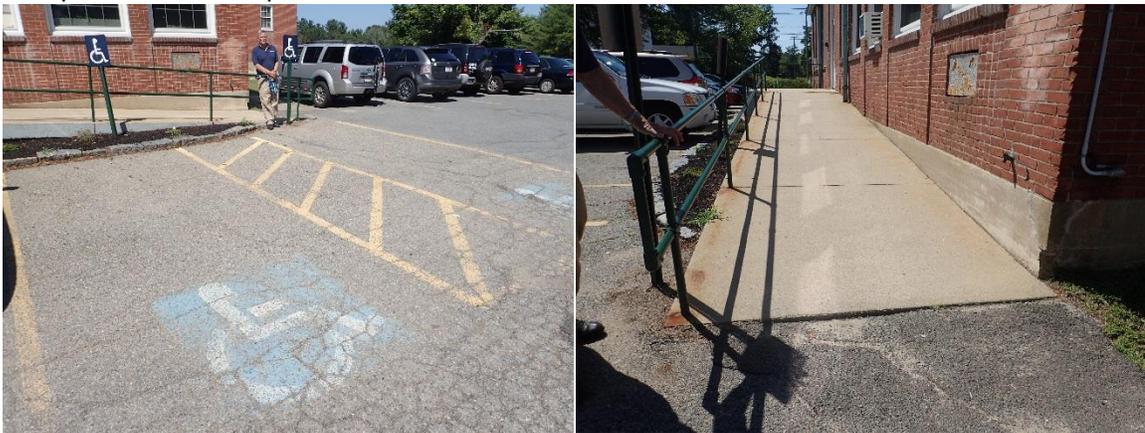
South Entrance (original building) (2 spaces)

The spaces are general compliant for slope, access aisle and signage. Pavement in and around the spaces is in fair to poor condition.

A straight run concrete access ramp leads to the building entrance. This ramp is generally in conformance with ADA standards for dimension and slope, but has the following deficiencies:

- Settlement of the adjacent pavement and the ramp itself have resulted in irregular vertical steps at the top and bottom of the ramp, in excess of ½”.
- handrails are provided only at one side of the ramp

ii. Correct paving at base of South entrance ramp to eliminate vertical gap between asphalt and concrete.

Resurface (grind or overlay) concrete landing and/or ramp to eliminate uneven “step” at top of ramp.

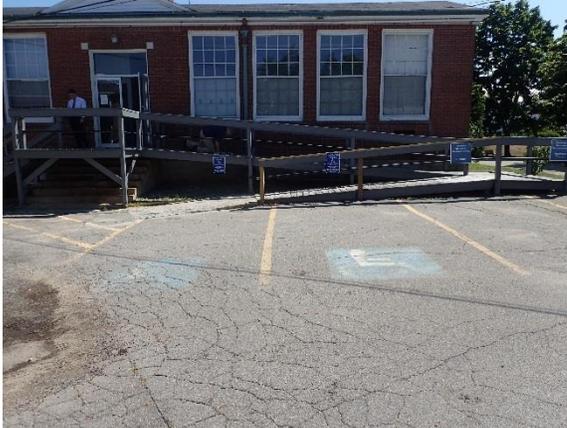
North Entrance (original building) (2 spaces)

The front-to-back and cross-slope of the spaces exceeds the ADA standard of 1:48 (1.2 degrees). The route to the access ramp also exceeds the allowable slope and crosses asphalt pavement in very poor condition. There is no designated access aisle and the lower space is overlapped by a portion of the adjacent ramp.

A switchback wood access ramp leads to the building entrance. This ramp is generally in

i. Regrade and resurface accessible parking at North entrance, in conjunction with corrections to the access ramp and landing. Provide ADA-standard parking spaces and access aisle(s).

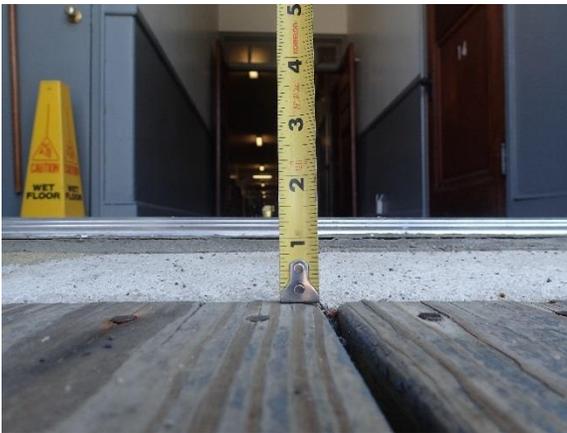
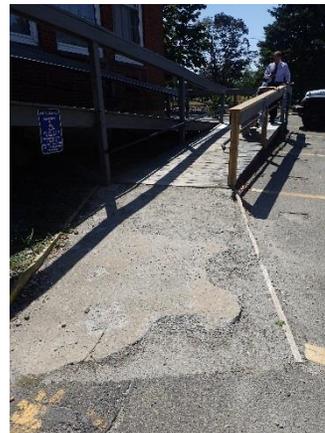
conformance with ADA standards for dimension, slope and railings, but has the following deficiencies:

- gaps between planks exceed ½”
- Top landing approximately 1-1/2” below the building floor
- Deteriorated, irregular concrete at lower section with excessive “step” to wood portion of ramp.

In conjunction with accessible parking corrections noted above, reconstruct or replace entrance ramp to provide top landing within ½” of the building floor and to eliminate excessive gaps between planks. Verify that one door leaf is 36” wide; replace doors with “unbalanced” set as necessary. Consider adding a power door operator for consistency with other Town buildings.

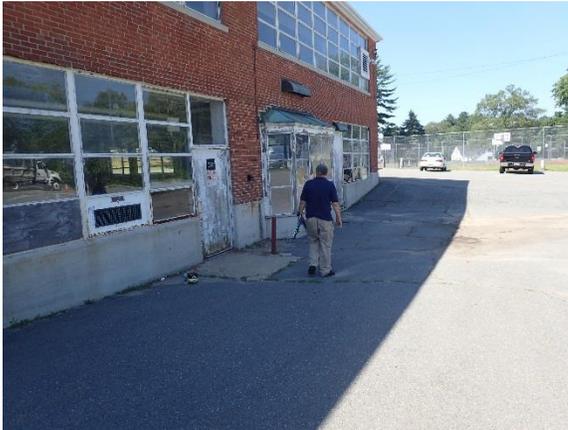
East Parking (3 spaces)

These spaces are part of a longer row of angled parking. They do not meet ADA dimensional requirements, lack access aisles and required signage. The route from these spaces to the building entrance was not evaluated.

The building entrance closest to these three spaces is not usable and could not be evaluated. No signage or exterior hardware was noted. The exterior landing did not appear to conform to ADA dimension, slope and surface requirements.

- i. Assess the actual needs for and optimum locations of accessible parking based on projected uses of different areas of the building. For example, there are no current programs or activities using the basement (lower) level, so the three designated parking spaces at the East side parking lot are of little or no benefit.

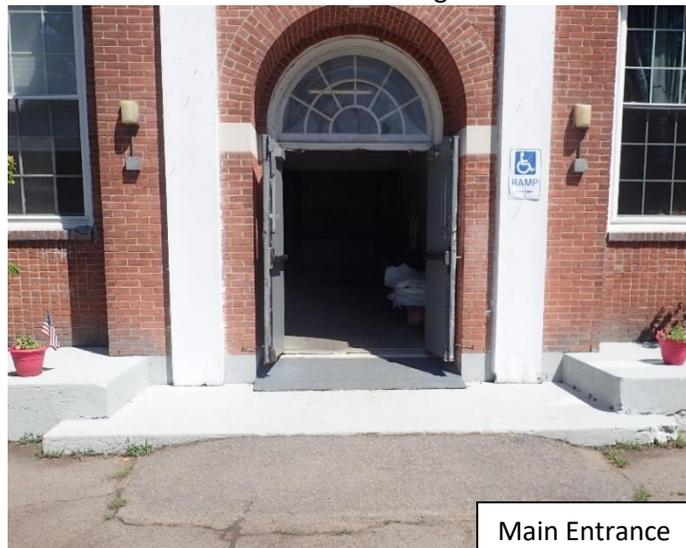
Main (front) entrance

The main entrance is not accessible. There is an interior ramp which appears to have been built over the original steps, but the ramp is excessively steep and lacks handrails. There is no level landing at either side of the entry door, and the threshold exceeds the allowable height.

The main (East) entrance door has a non-compliant ramp and threshold and threshold.

The dimensional limitations of this space do not allow the installation of an ADA-compliant ramp. The current ramp is excessively steep and lacks handrails and a level bottom landing; as such it may pose a safety hazard, particularly for unattended wheelchair users. Consider removing the interior and exterior ramp elements and returning to the original configuration of the entrance.

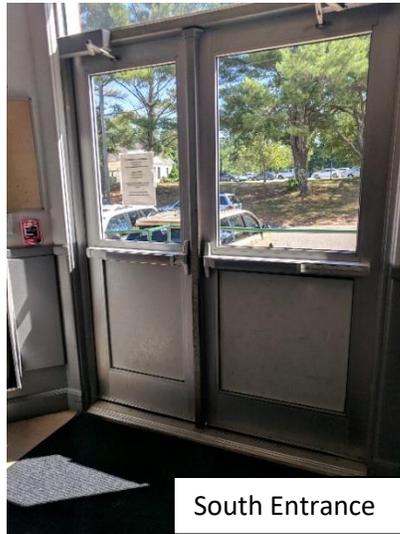
The South entrance is generally ADA-compliant. It was noted that the double entrance doors are provided with unequal leaves in order to accommodate the required 36" wide door.

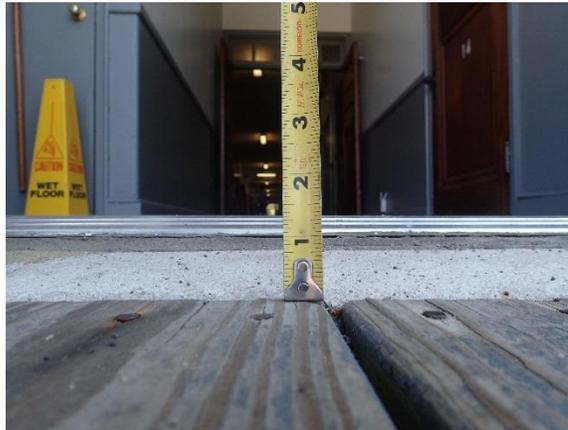
The North entrance is not accessible due to the excessive drop (1-1/2") from the threshold to the exterior landing, as noted above. The entry doors also appear to be of equal width and may not meet the required 36" opening for a single leaf. This needs to be verified.

The North Entrance has a non-compliant ramp and landing, as well as deteriorated paving along its access route.

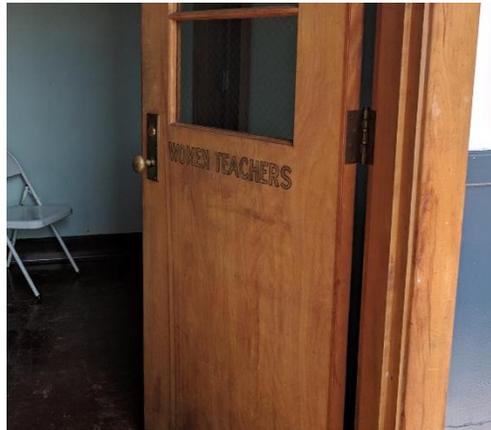
The interior signage at the Recreation Center is limited and typically does not meet ADA standards. Some permanent rooms and spaces are clearly identified, but the signage is not mounted at consistent heights or locations and lacks the required raised lettering and Braille characters.

Provide consistent ADA-standard signage for all accessible doorways, routes and spaces.

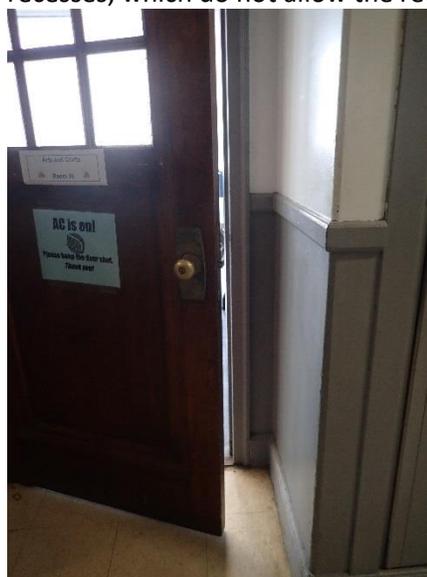
Almost without exception, the interior doors and doorways at the Recreation Center do not meet to ADA accessibility standards. This is typically due to one or more of the following conditions:

- Lack of appropriate hardware. Most doors have standard doorknobs, which cannot be operated with a closed fist or without grasping. Lever handles or simple push-pull hardware are required.
- Lack of adequate side clearance at doors. A minimum 18" clearance is required at the latch-pull side of any passage or entry door. In some cases this is the result of furniture placed too close to the door; in other cases the door swing or location is problematic. In addition, where automatic door closers are used, a minimum 12" clearance is also required at the latch *push* side; however, few if any automatic closers were noted at Town Hall other than at the restrooms.
- In many cases the doors opening off the main corridor are set in deep recesses, which do not allow the required latch side clearances.

Provide lever-handle hardware at any doors expected to be used by the general public. Ensure single-action release (from the room or exit side) of doors subject to locking (i.e., no separate deadbolts, etc.)

Remove or relocate furniture to allow 18” clear at the latch-pull side of doors, plus 12” clear at the latch *push* side where the door is equipped with a closer.

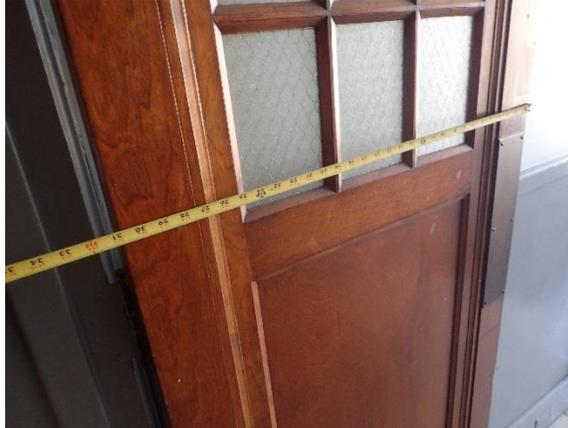
- Where original double (pair) doors exist, the overall opening size is approximately 5'-4". Each door leaf is approximately 32" wide, below the ADA standard 36".

Reconfigure door openings and/or change door swings to allow 18" clear at the latch-pull side of doors, plus 12" clear at the latch push side where the door is equipped with a closer.

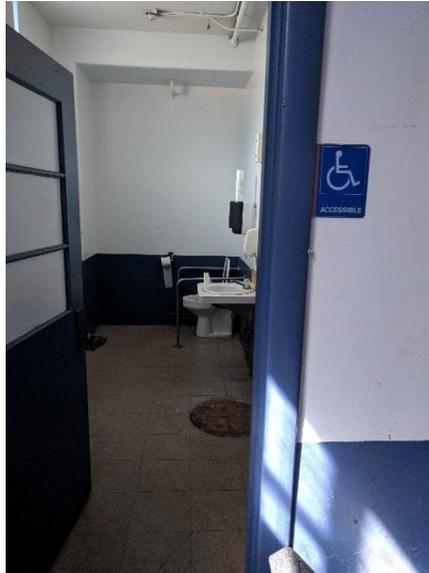
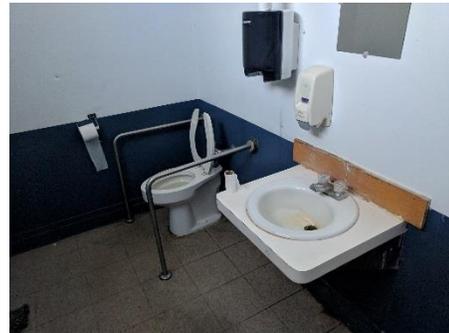
- ii. There is one toilet room designated as accessible. While the room itself is large enough to allow full compliance, the following elements do not meet ADA

standards:

- Door Hardware
- Grab Bars
- Rear wall clearance at toilet
- Lavatory handles
- Lack of closure panel or insulation at water piping under lavatory
- Placement of paper towel dispenser

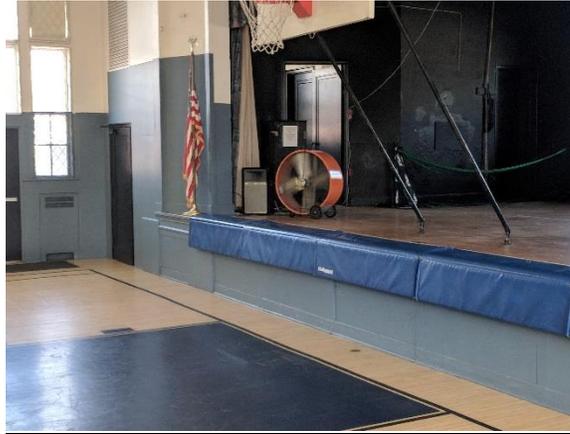
The raised Gymnasium stage and backstage areas are also not accessible.

These areas are not accessible, and no equivalent accommodation exists.
